ROCKWOOD WATER, SEWER, AND GAS

# 2022 CMOM ANNUAL PROGRESS REPORT

NPDES PERMIT TN 0026158

Submitted 1/31/2023

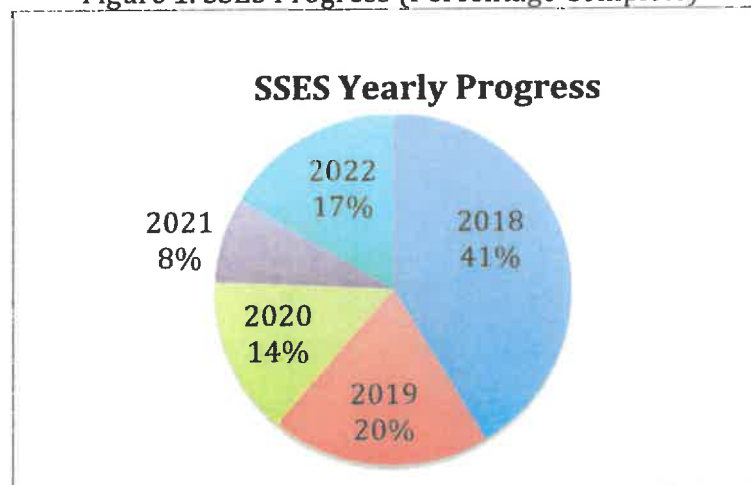
Figure 1. SSES Progress (Percentage Complete)

In late 2022, the fifth and final phase of the SSES program was completed. This completed approximately 100% of our system-wide attempted inspections. See Figure 1.

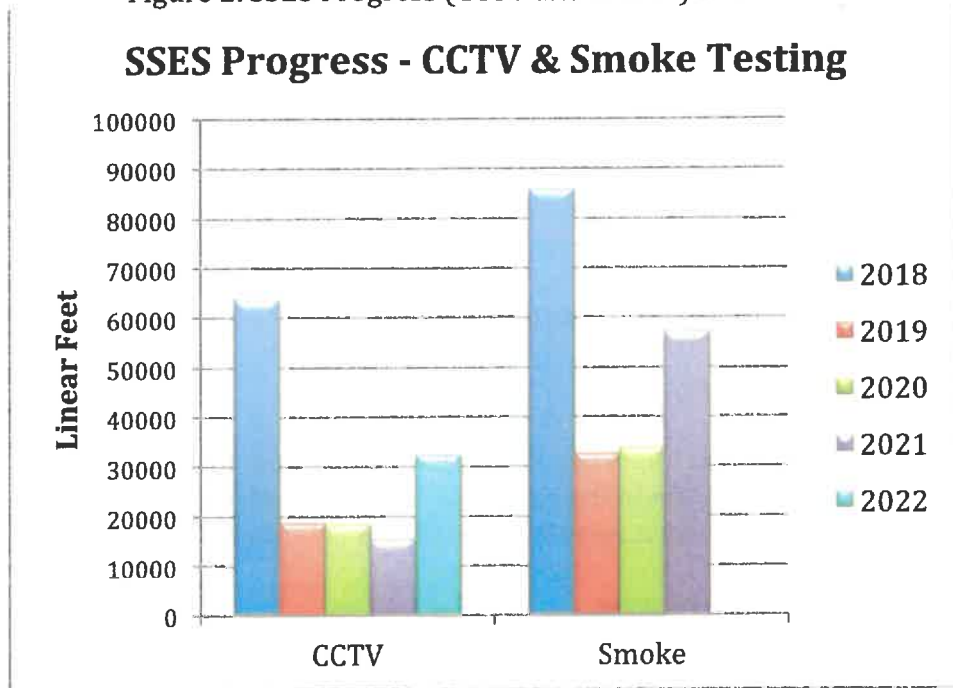
Figure 2. SSES Progress (CCTV and Smoke) 2018 -2022

In 2022, RWSG CCTV'ed 32,393 feet of main. See Figure 2 and Appendix B.

In 2022, RWSG Smoke Tested 0 linear feet of gravity main. The final smoke tests were completed in the last quarter of 2021. See Figure 2 and Appendix C.

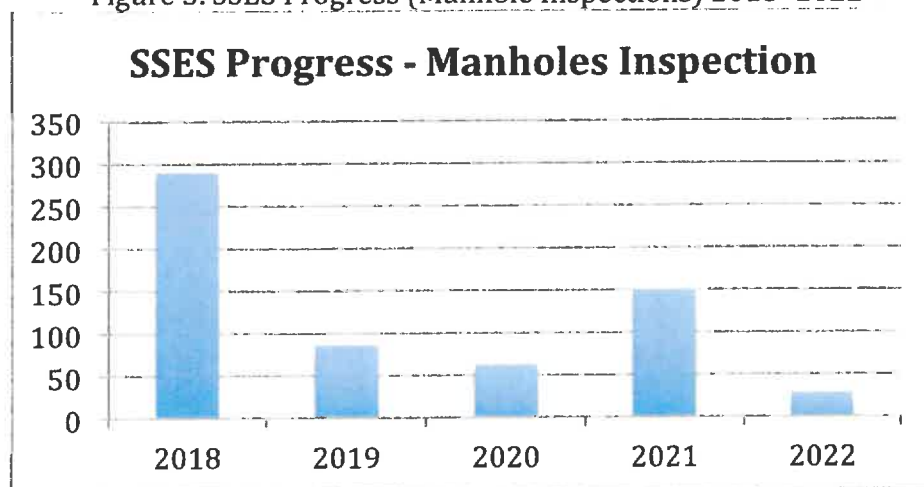
Figure 3. SSES Progress (Manhole Inspections) 2018 -2022

In 2022, RWSG inspected 29 manholes. See Figure 3 and Appendix D.
